Model: All Canrig Top Drives

Product Bulletin # TDS-239 Rev 7

Die Block Inspection

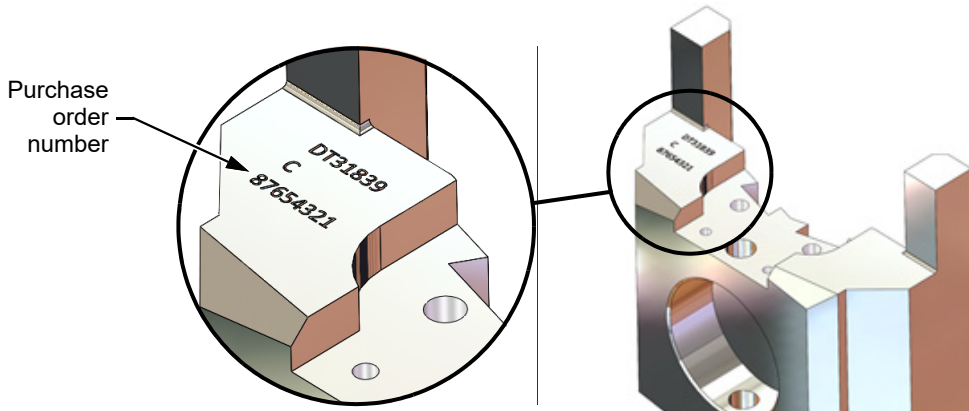
Figure 1: Location of stamped purchase order number

See Figure 1 for location of stamped purchase order number on the part.
